Case study

Delivering foundations for the future

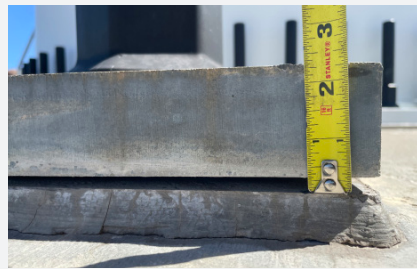
Figure 1: Gap in bearing plate

Based on gaps found (figure 1) under the bearing plate on one of the foundations, the client identified damage to the anchor foundations of one turbine. They also suspected risk of further damage to other foundations on the site.

The turbine was shut down until repairs were made due to the extent of the damage identified. And since there was no clear root cause, the client knew they required a monitoring strategy to warn them of future damage to the site's foundations.

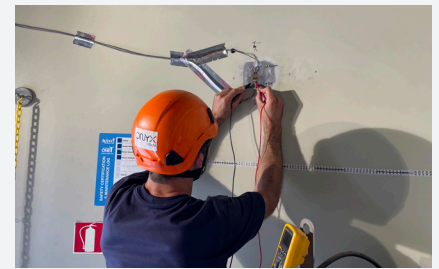
Figure 2: Strain gauges

ONYX engineers installed strain gauges (figure 2) and inclinometers on the two turbines. In addition to this, our team collaborated with the client's site team to install ecoCMS, our advanced sensing solution, across a total of five turbines to acquire a comparative data set.

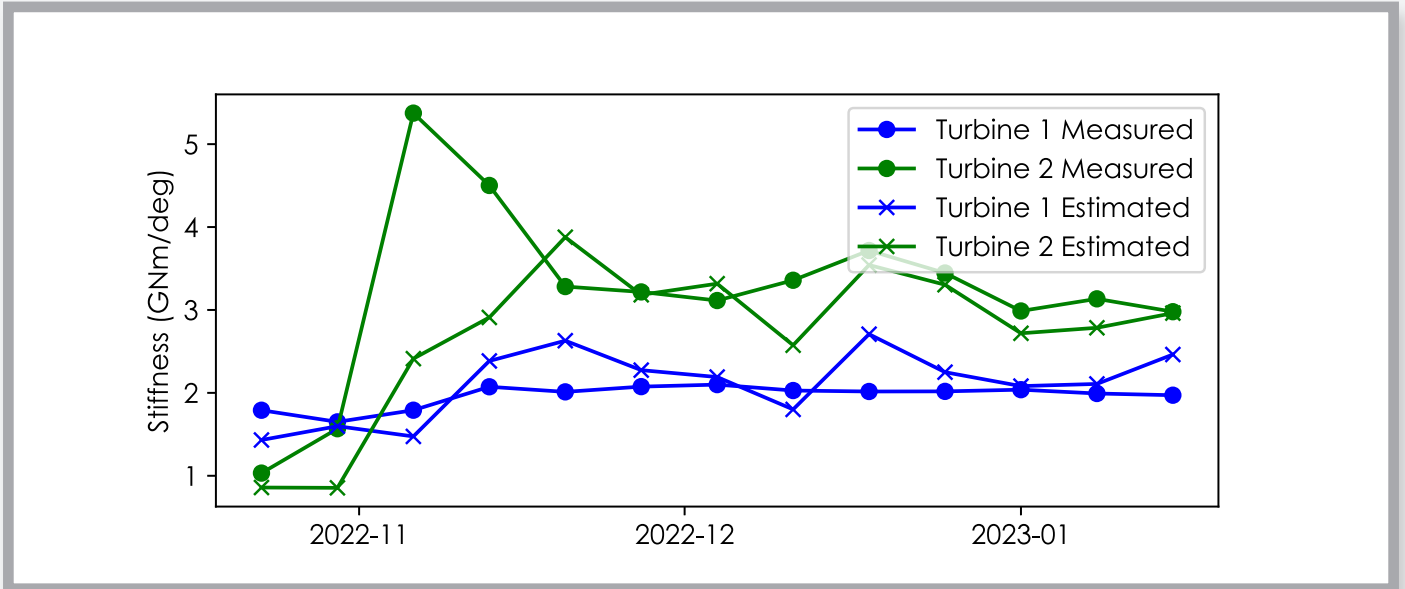
Figure 3: Stiffness of 2x Turbines with ecoCMS and Strain Gauging

In addition to this, engineers correlated the rotational stiffness from the two turbines with the ecoCMS data, providing the client with **stiffness estimates for all turbines** monitored by ecoCMS. This allows comparison with OEM stiffness requirements, even when on turbines where stiffness monitoring did not occur.

Analysing the data, our team **clearly identified** the indicators of the foundation damage (and the indicator to identify if anchor tension degraded again), before needing to shut down the turbine.
